Water Quality

WOTS Reservoir Erosion Control and Revegetation Workshop and Demonstration

Smithville Lake, Smithville, Missouri

by Hollis H. Allen, Michael A. Watkins, and Bruce K. Clark

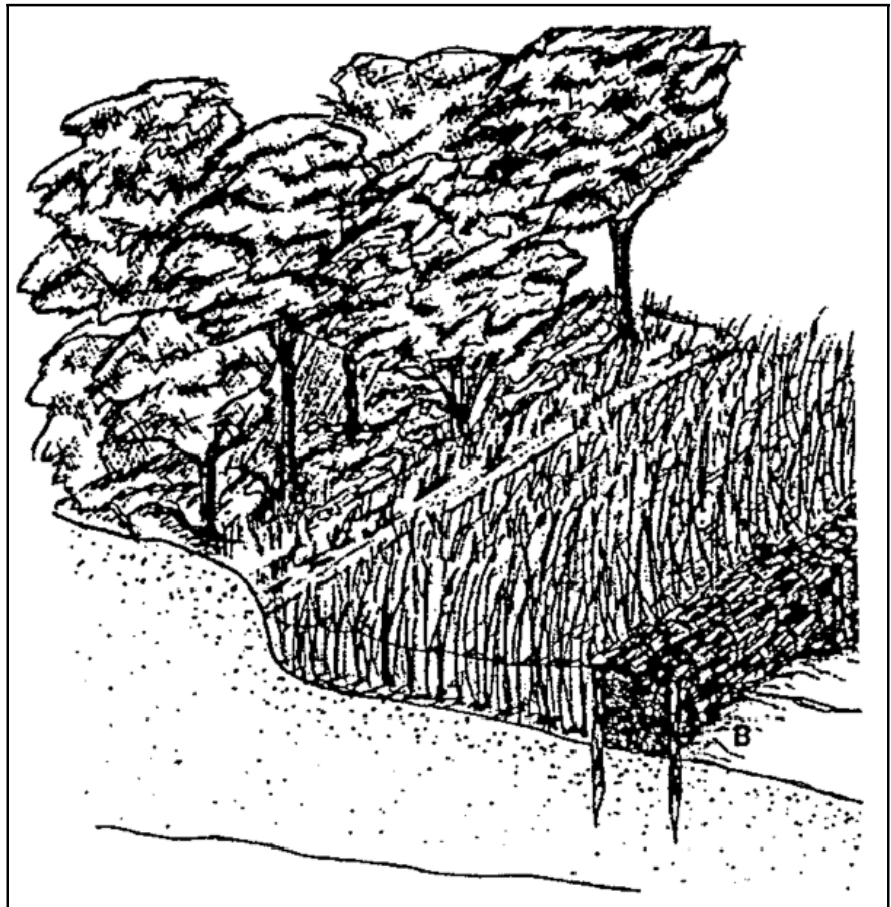
Figure 1. Schematic of branchbox breakwater with wetland vegetation planted shoreward of breakwater

One of the wave breakwater treatments consisted of a “branchbox breakwater,” one modified from a European breakwater design shown in Figure 1. The breakwater was designed to be a temporary structure to diminish wave energy and provide time for plant establishment. Its purpose was to develop a stable slope for revegetation behind the breakwater. In summary, the breakwater generally consists of bundles of dead brush, called fascines, that are laid down between two rows of parallel poles. The poles are loosely driven at first with wire laced between the rows; then the poles with wire are firmly driven further into the lake bottom to secure the bundles of dead brush in the form of a breakwater composed of a brush wall. The 50-ft-long breakwater was positioned about 10 to

15 ft out from the bank and was planted behind with emergent aquatic vegetation.

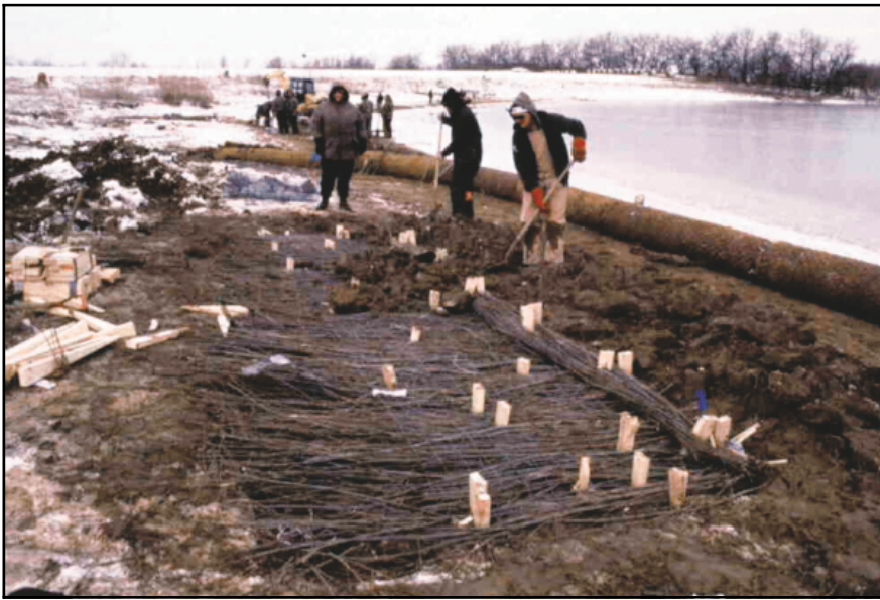
Figure 2. Breakwater made from a coir geotextile roll with workshop participants installing a brush mattress made from willow

The second breakwater treatment consisted of a coir geotextile breakwater that covered 130 ft of shoreline. The breakwater, like the one above, was designed to be temporary. It will diminish wave energy and will allow plants to be planted both behind and in it. The breakwater was constructed of nonwoven coir fiber made from coconut husks and bound by either a choice of woven coir rope or polyethylene rope. The demonstration breakwater was 20 in. in diameter and was bound by polyethylene rope for durability in a wave environment. The shoreward side of the breakwater was planted with emergent aquatic vegetation immediately adjacent to the breakwater, with live willow whips laid down and secured as a brush mattress, in accordance with methods described in Allen and Leech (1997). The coir breakwater with an incom-

plete brush mattress is shown during installation in Figure 2.

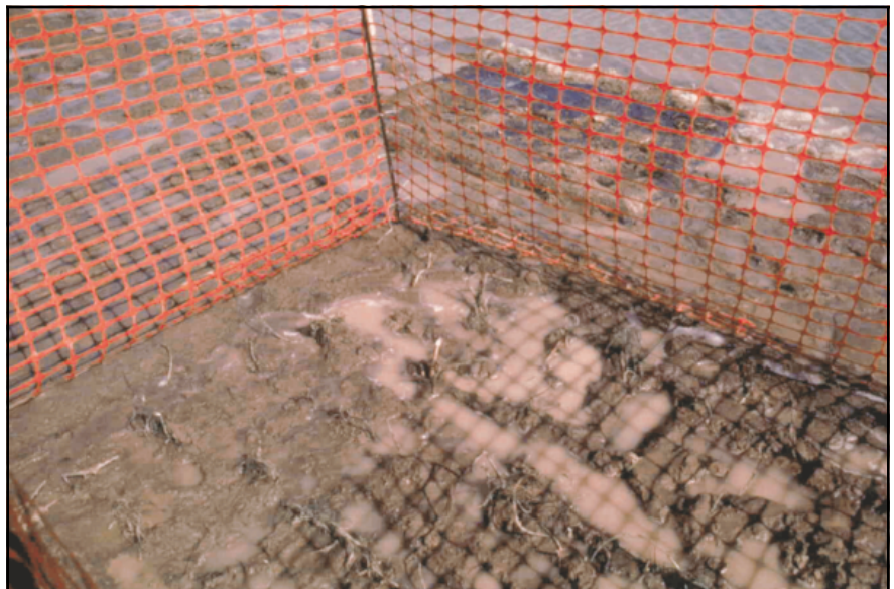
Figure 3. Patch of emergent aquatic plants immediately after planting in a coir geotextile mat. Geosynthetic grid fence surrounding patch serves as a geese and carp exclosure

matrix of coir fibers to facilitate root development. Several 4- by 4-ft patches of these mats were installed in a checkerboard pattern, and each mat was backfilled with soil to fill the voids. Because of possible herbivory problems from carp and geese, about one-third of these patches were fitted with a perimeter of geosynthetic grid, similar to those commonly used for safety fences around construction sites. Thus, they served as exclosures

to geese and carp. Figure 3 shows one of these patches with the fence around it. Landward of the 4- by 4-ft patches of emergent aquatic plants, both dormant willow poles and willow cuttings were planted. A backhoe with an attached “stinger,” as described by Hoag (1994), facilitated the use of 8- to 10-ft long willow poles (Figure 4).

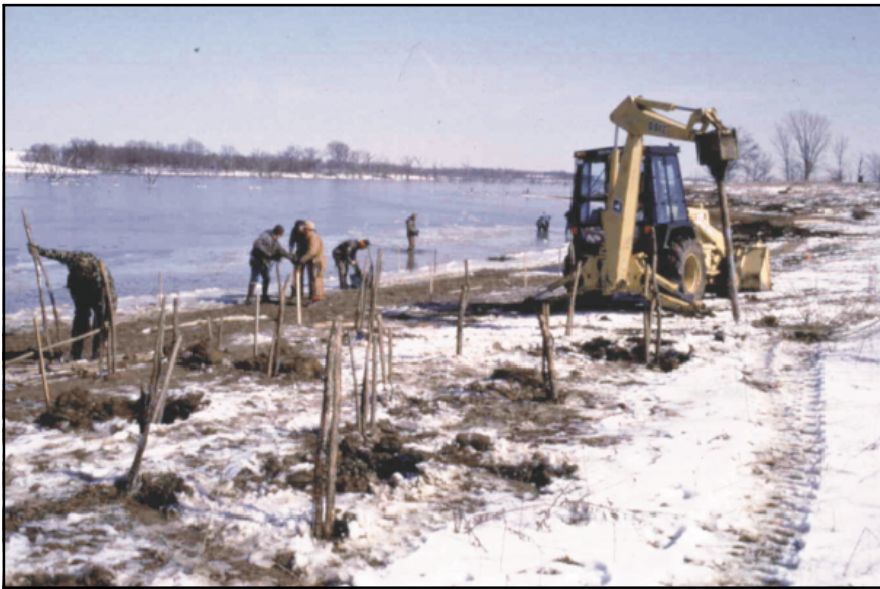
Figure 4. Dormant willow posts being installed with the aid of a backhoe mounted with a “stinger”

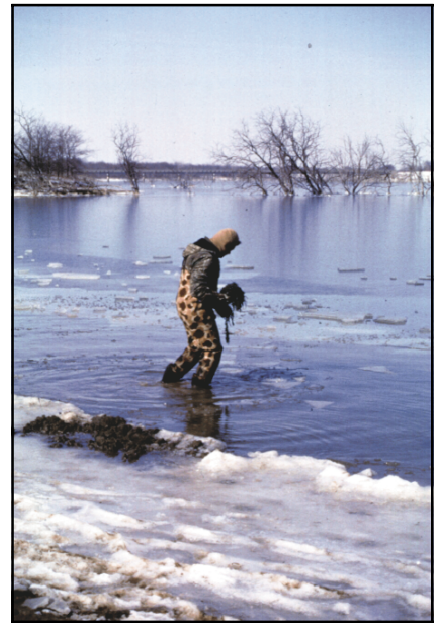
Figure 5. Submersed aquatic vegetation, such as coontail, being deposited in shallow water

vegetation, such as coontail (*Ceratophyllum demersum*) were simply deposited in about 1 to 2 ft of water (Figure 5).

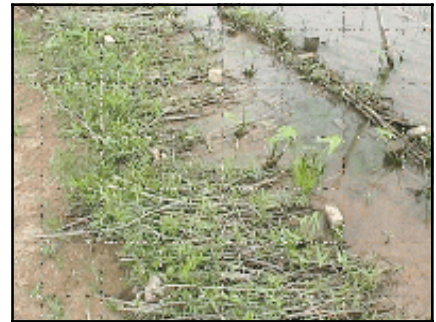
Figure 6. Brush mattress behind coir geotextile roll showing sprouts of willow and arrowhead

The demonstration treatments were revisited in August 1998 by Corps personnel. Both areas behind each breakwater type, the branchbox and the coir geotextile roll, were capturing sediment and essentially reclaiming eroded shoreline. Particularly, new vegetative sprouts were occurring in the brush mattress behind the roll. These included both young willow and other emergent aquatic plants such as broad-leaved arrowhead (*Sagittaria latifolia*) (Figure 6). Other emergent aquatic plants were observed shoreward of the roll (Figure 7). The coir roll breakwater was intended to be planted by inserting sprigs of emergent aquatic plants in it. This action was postponed until lake levels were high enough to wet the roll so plants would not dry out. This planting may take place in the spring of 1999.

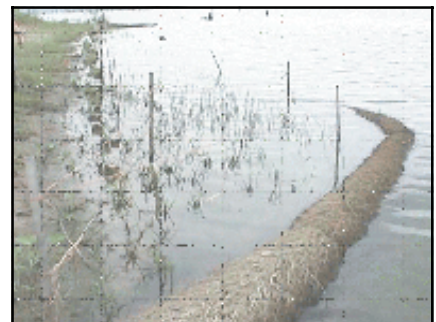
Figure 7. Aquatic plants emerging behind wave breakwater made from coir geotextile roll

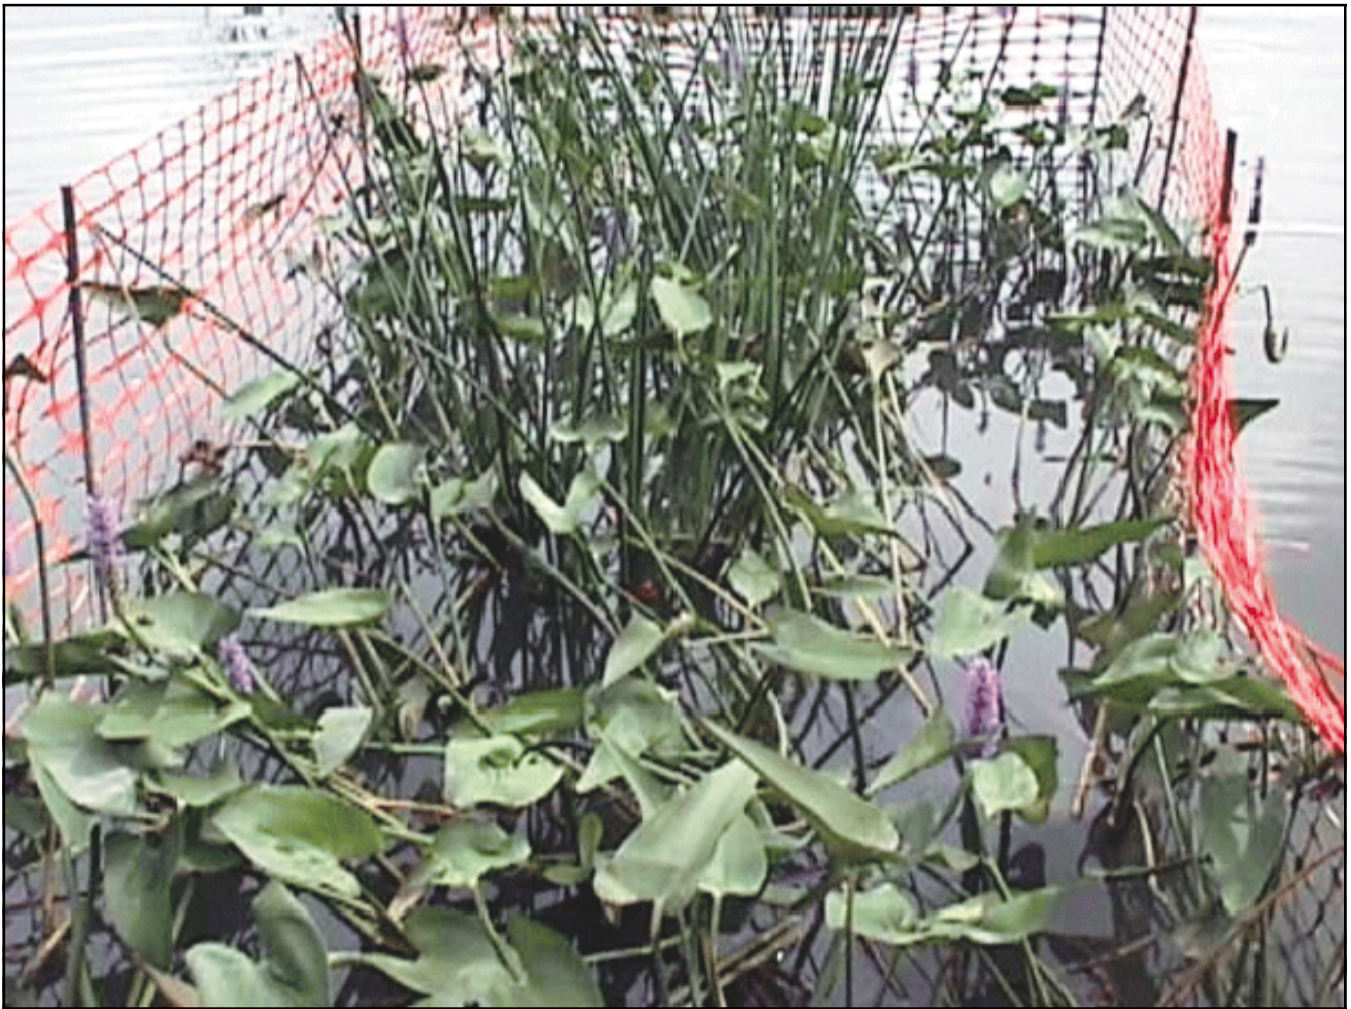
Figure 8. Emergent aquatic plants such as pickerel weed and three-square within an enclosure

Treated areas without breakwaters were most noticeable by the occurrence of emergent aquatic plants in the exclosures, most notably pickerel weed (*Pontederia cordata*), three-square (*Scirpus americanus*), and other bulrush species (*Scirpus* spp.) (Figure 8). Where exclosures were not present, aquatic plants were scarce. The exclosures probably prevented the plants from being extirpated by both geese and carp. Carp are abundant in the reservoir, particularly shallow areas, and the reservoir is noted for its large population of geese, which graze on aquatic vegetation.
